Motorcycle Skidding (rear only vs front & rear)

Plumbing Related Water Damage Cases

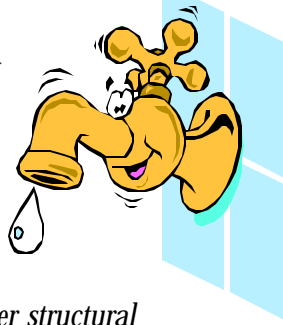
In another case, a new home was extensively damaged when a leak occurred in a second story bathroom. The damage was to ceilings, hardwood floors, and other structural systems on the first floor.

VCE's investigation determined that during installation of a bathtub, the plumber had over-tightened a metal fitting into a female PVC adapter. It was experimentally determined that excessive strain was induced when metal fittings are over-tightened into plastic female fittings. This strain results in eventual stress fatigue and failure of the plastic fitting. This type failure typically occurs some period of time after the assemble is made and tested. In this case, this was several days later.
